Manhole Inspection Summary

Manhole # S43A2_034MH

Insp Date: **12/12/07 7:41 AM**

Location Address: **3601 Saint Margaret St**

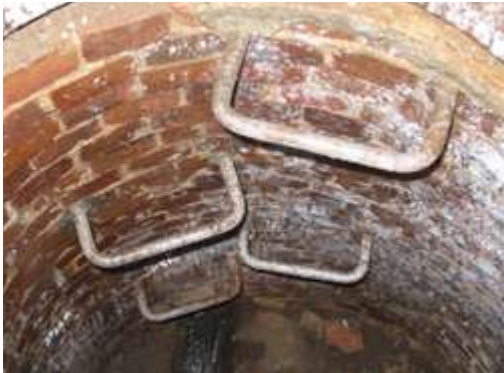
Steps Count: **4** Missing: **0** ☐ Corroded

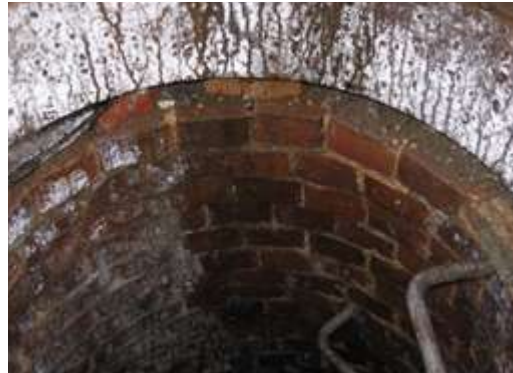
Defect 1

Condition: ☐ Sound ☐ Cracked ☐ Root Intrusion ☒ **Loose Brick** ☐ Deteriorated

Infiltration: ☐ None ☐ Joint ☐ Cracks ☒ **Mortar** ☐ Roots ☒ **Wall**

Loose bricks

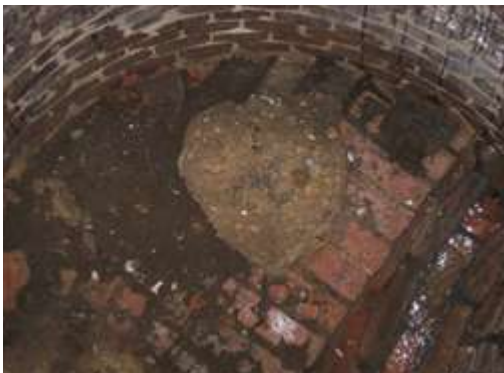
Defect 2

Large piece of debris

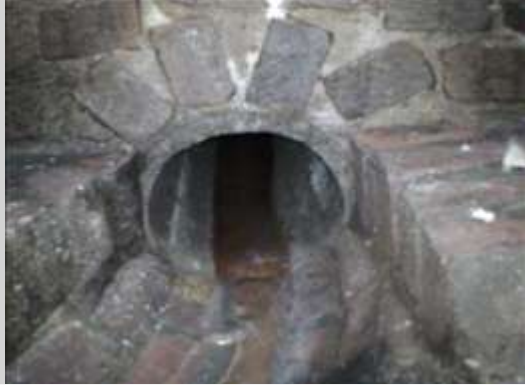
12 O'Clock Outflow

8 in. Circular Gravity Sewer
Pipe Out @ 12 O'Clock

Pipe Height: **9.6** (in.) Rod and Bar (Angled)
Pipe Material: **Clay** ☐ Pipe Lined
Invert Depth: **7.80** (ft.) Flow Characteristics: **Fast**
Deposits: ☒ None ☐ Mud ☐ Sludge ☐ Debris ☐ Grease
Silt Depth: (in.) Deposits Extent:
Infiltration: **None** Pipe Seal Cond: **Sound**

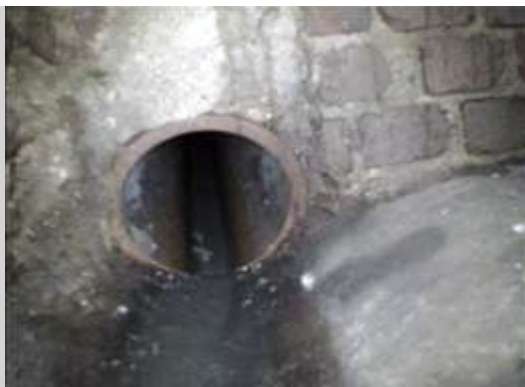
4 O'Clock Inflow

6 in. Circular Gravity Sewer
Pipe In @ 4 O'Clock

Pipe Height: **6** (in.) Rod and Bar (Angled)
Pipe Material: **Clay** ☐ Pipe Lined
Invert Depth: **7.06** (ft.) Flow Characteristics: **Fast**
Deposits: ☒ None ☐ Mud ☐ Sludge ☐ Debris ☐ Grease
Silt Depth: (in.) Deposits Extent:
Infiltration: **None** Pipe Seal Cond: **Sound**

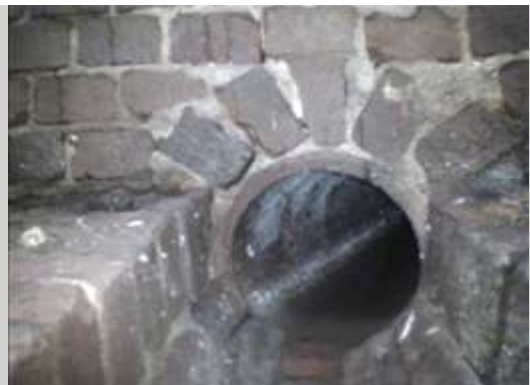
9 O'Clock Inflow

Pipe Height: **9.6** (in.) Rod and Bar (Angled)

Pipe Material: **Clay** ☐ Pipe Lined

Invert Depth: **7.57** (ft.) Flow Characteristics: **Fast**

Deposits: ☒ None ☐ Mud ☐ Sludge ☐ Debris ☐ Grease

Infiltration: **None** Pipe Seal Cond: **Sound**
